Manhole Inspection Summary

Manhole # S37KK_034MH

Insp Date: **3/19/07 10:59 AM**

Location Address: **1812 GREENMOUNT AVE**

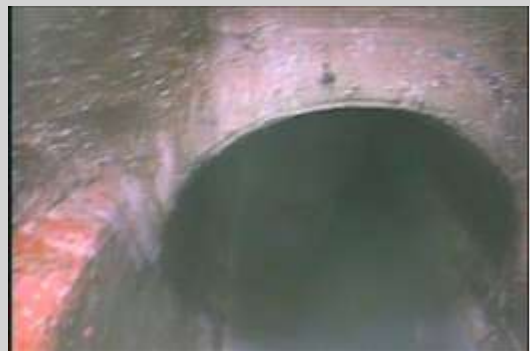
27 in. Circular Gravity Sewer Pipe In @ 6 O'Clock

Pipe Material: **PVC** ☐ Pipe Lined

Invert Depth: **8.16** (ft.) Flow Characteristics: **Fast**

Infiltration: **None** Pipe Seal Cond: **Unknown**
